Cristina Juanos Cabanas, Tchien Minh Tang, Pierre De Cannière

Bending Observed on the Carbon Steel Liner of the Pre-stressed Concrete Primary Containment of a Nuclear Reactor: Safety Assessment

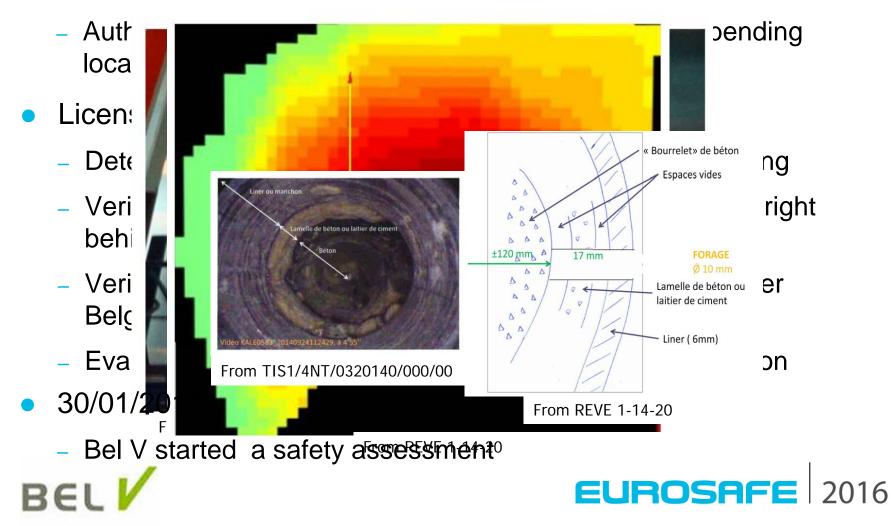
• 7/09/2014:

- On 7/09/2014: Bending (2.7 m wide, 1.9 m high, maximum curving of 14 cm) was observed on the liner of the primary containment
- National and international literature did not show similar reported bendings
