F.Schmitz, C.Peters, M.Van haesendonck, P.Carlier (FANC)

Safety Improvements of an Industrial Irradiation Facility

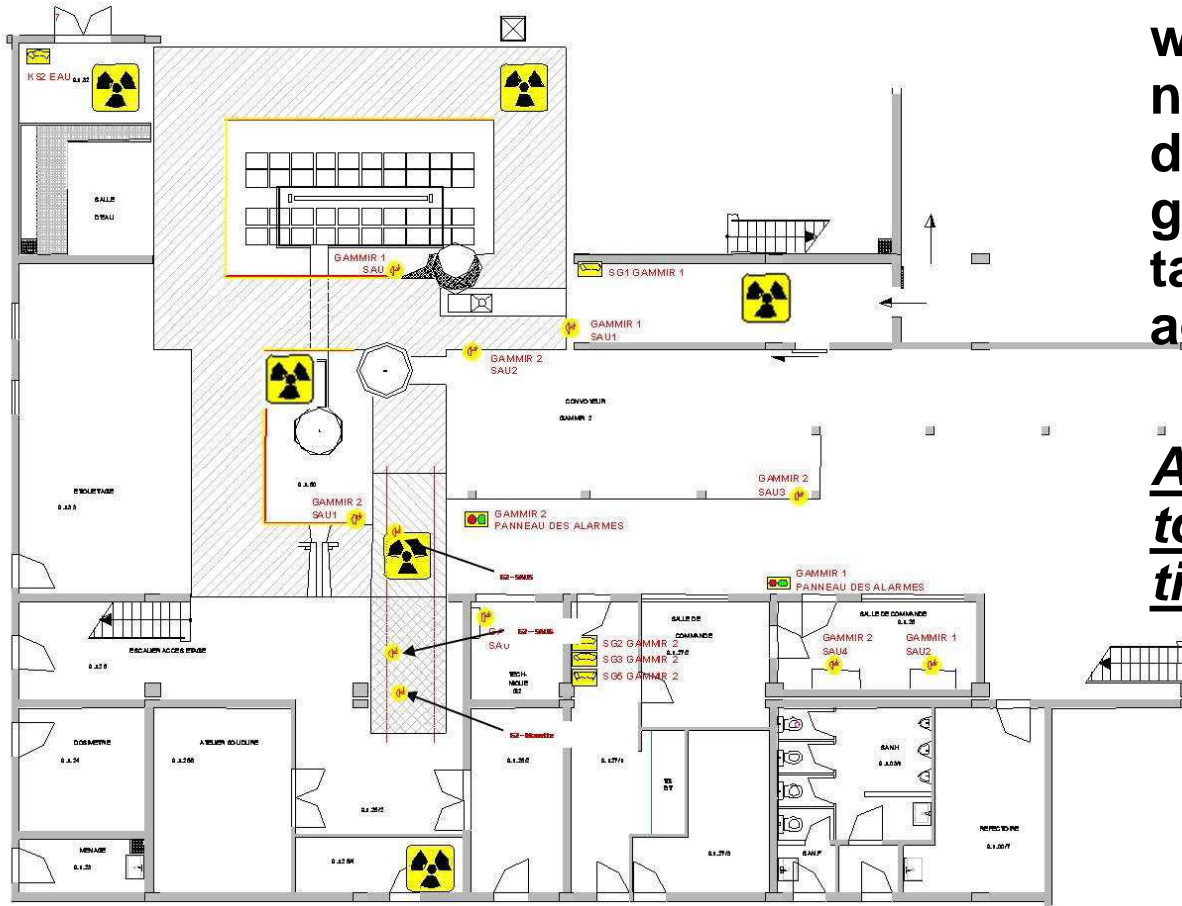
Accident of March 2006

Severe irradiation of a worker (4.2 Gy), worker did not wear his dosimeter, did not use a portable gammameter and did not take any alarm into account

As a result, it was decided to remove the safety delay timer for patrol

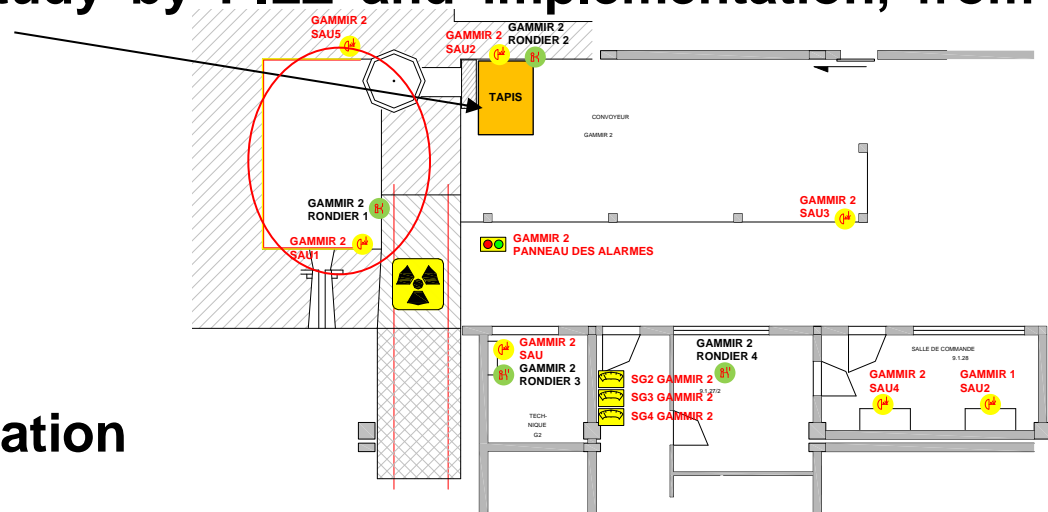
- A maintenance technician was trapped in the Gammir II irradiator. He actuated an emergency stop before the irradiation sequence began.

- First phase, multiple consignations (one lock per person entering an irradiator), from May 2009
- Second phase, immaterial barrier and sensitive carpet, patrol is back (safety delay timer): study by PILZ and implementation, from Dec 2009

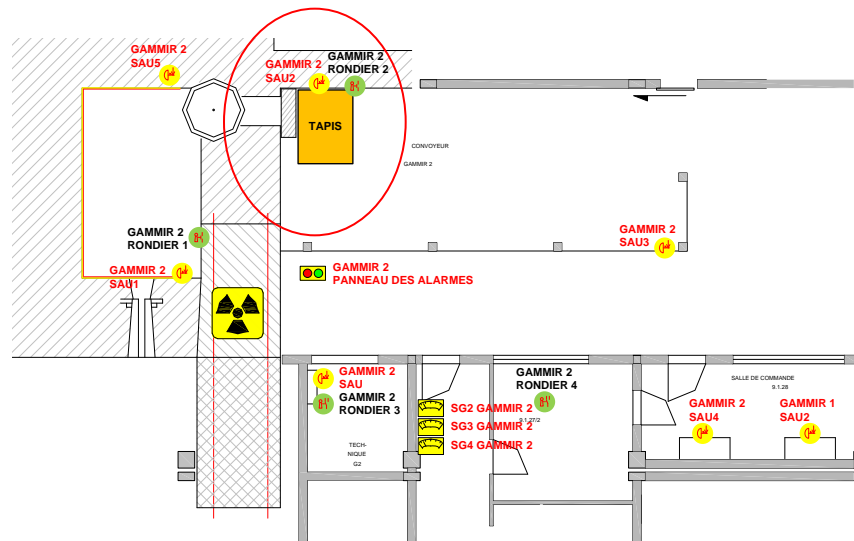
- Jump of one employee over the sensitive carpet

- Improvement : Modification of the layout around the carpet

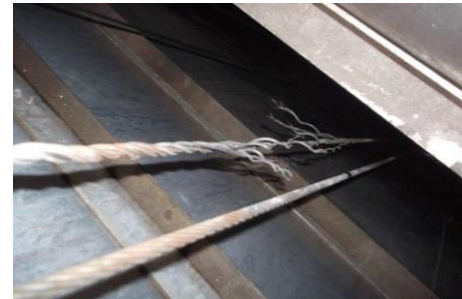
- Empty rack sources blocked in upper position due to damaged cable (12.11.2014). Reloading of the irradiator while still in degraded mode (16.11.2014) : Procedure describing degraded mode requested the locking of the irradiator at the end of the tests ; wrong communication between two teams; human and organisational factors.

- Replacement of the guide and traction cables and review of their preventive replacement frequency
- Test of the empty rack movements and of the damaged cables
- Test of the Revision of the degraded mode procedure to include a double check (project leader and control).
- Revision of the risk analysis taking into account the organizational and the human factor impact
