Structural damages observed on a safety-related structure following jet grouting activities: causes, safety assessment and implications

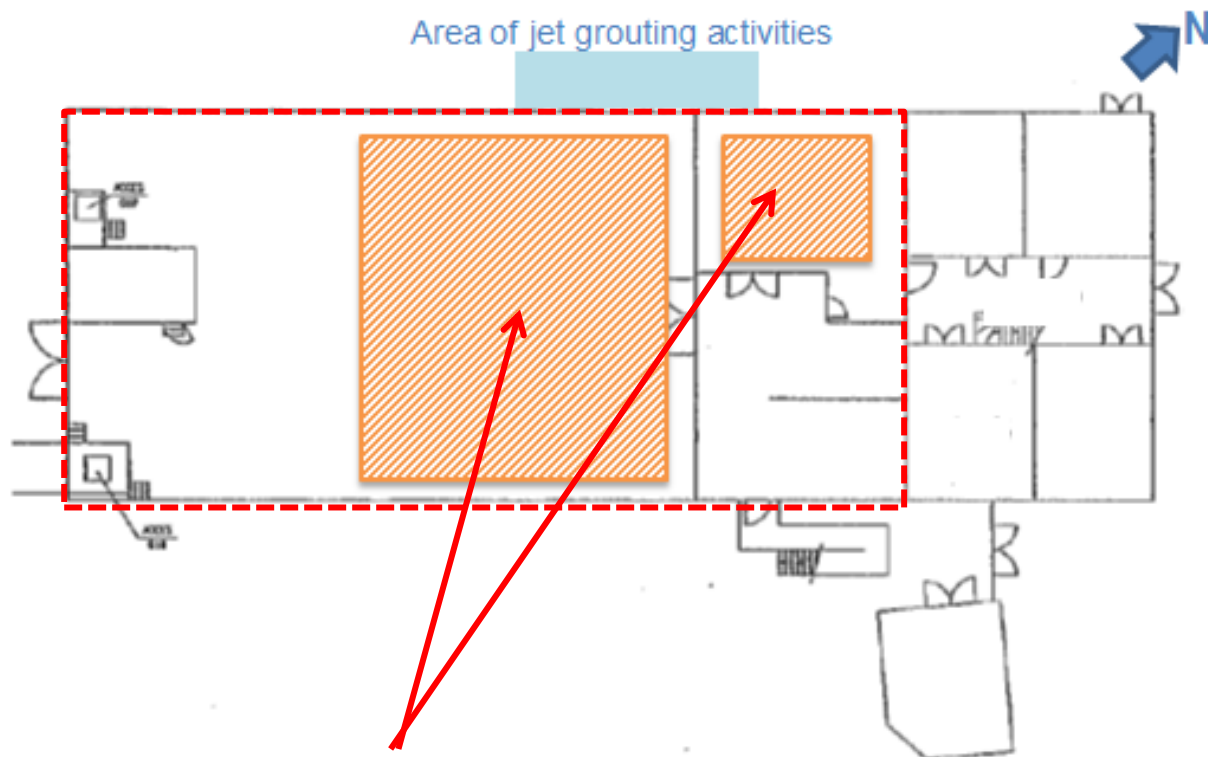
Areas with main structural damages within the **W building**

- 7/09/2016: the Licensee observed several damages at the ground floor of the W building:
 - Cracks all across the ground floor and across foundation slabs supporting the turbo pump and air compressors
 - Damaged joints and grout resurgence through damaged joints
 - **Displacements** of several components (fixed point)
 - Slab bended at several places
- The Licensee decided on the same day to stop the unit and the jet grouting activities in accordance with the plant Technical Specifications.

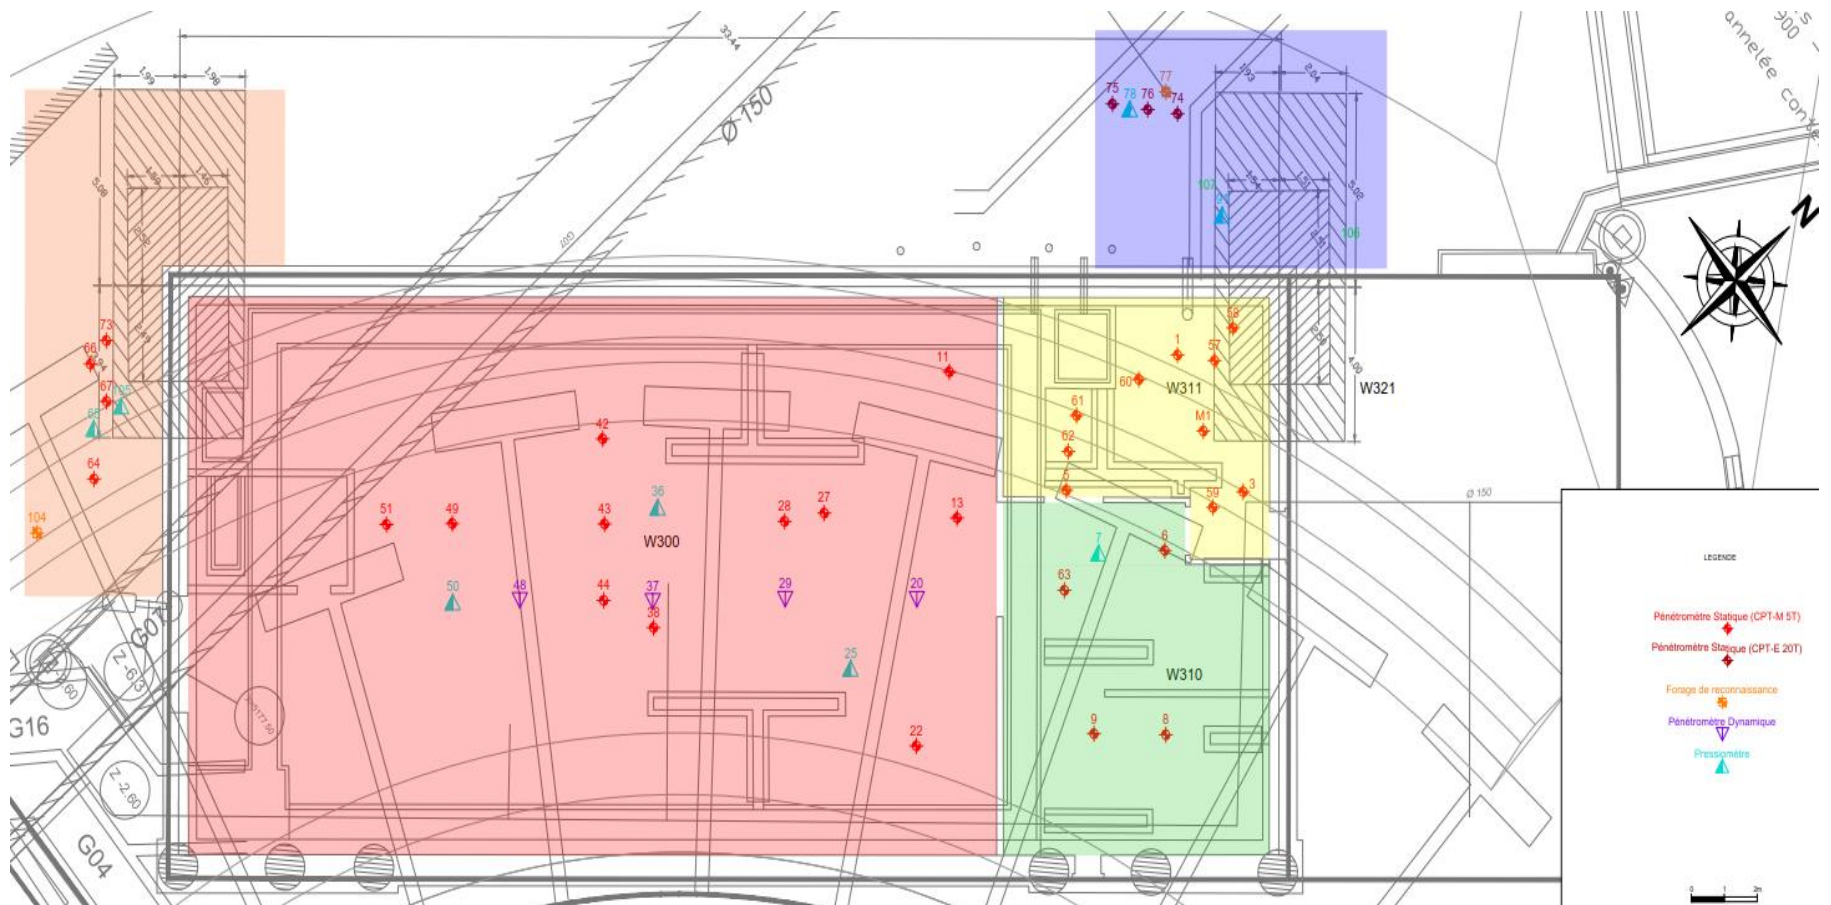
- Geotechnical & mineralogical investigations:

- Geotechnical & mineralogical investigations – results:
 - Heterogeneous backfill: burnt and unburnt shales, coal, sulfates/sulfides...
 - Probably mainly composed of mining wastes originating from the region
-

Different from the information provided on the construction plans and in the safety analysis report

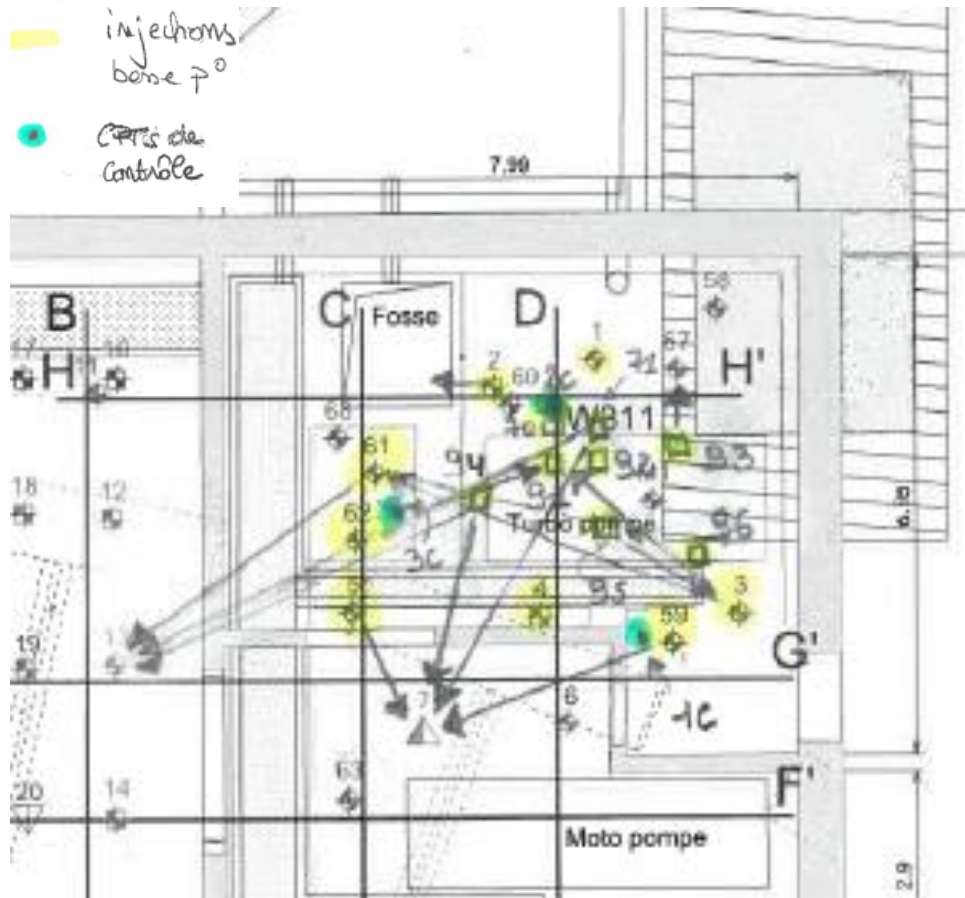
- Backfill material :

- Rapidly the Licensee carried out soil reinforcement under the auxiliary feed-water pump foundation
- Around 14 m³ were injected
- Pathways between injections
- Volume of voids was significant
