Secondary side corrosion of SG tube alloys in typical secondary side chemistries

OPEX of IGA/ODSCC (SG tube corrosion cracking)

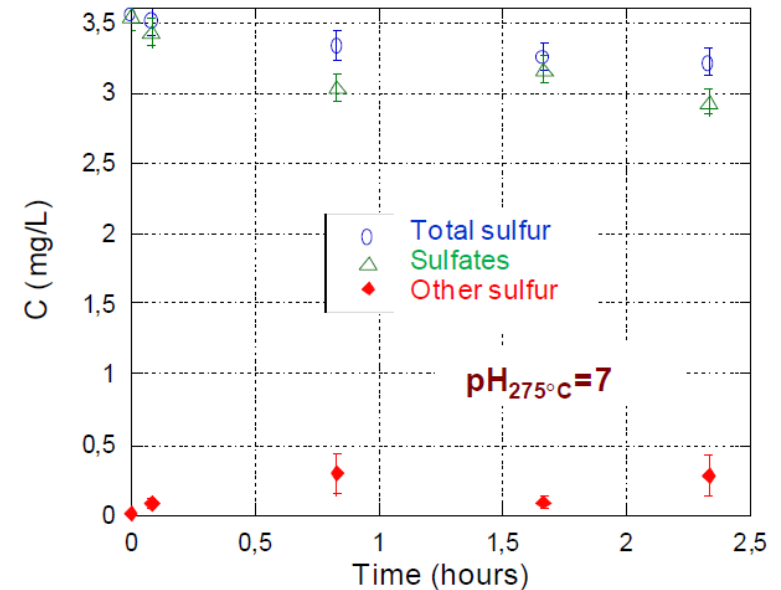
- Sulfates are measured at the SG blowdown
 - Sulfates in crevices may be 50 000x that measured during HOR
- In the operating SG, sulfates may be reduced
 - Magnetite, hydrazine...
 - Up to 10% of sulfur species in a « reduced » condition
 - According to pH_T

➔ Need to consider some reduced sulfur species in tests

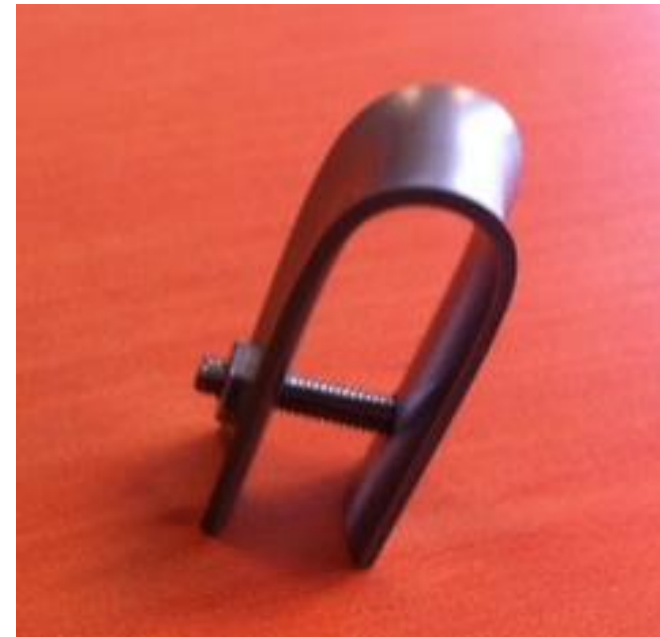
Test specimens : Reversed U Bend

RUB (1/6 SG tube)

Pre oxidized in nominal AVT environment

$\sigma \sim 550 \text{ MPa}$, $\varepsilon^p \sim 9-10\%$

9 specimens per capsule

6 sections per tube

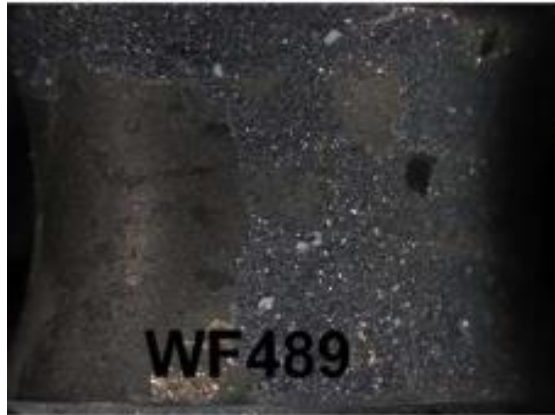
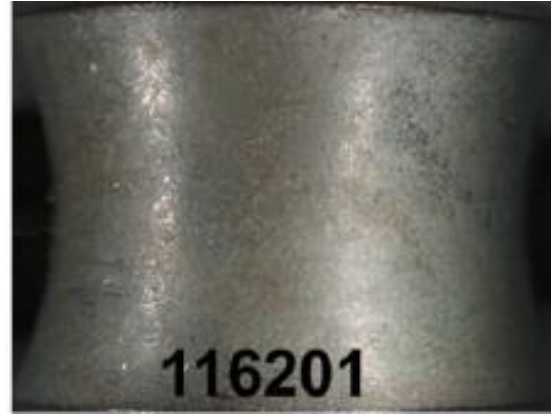
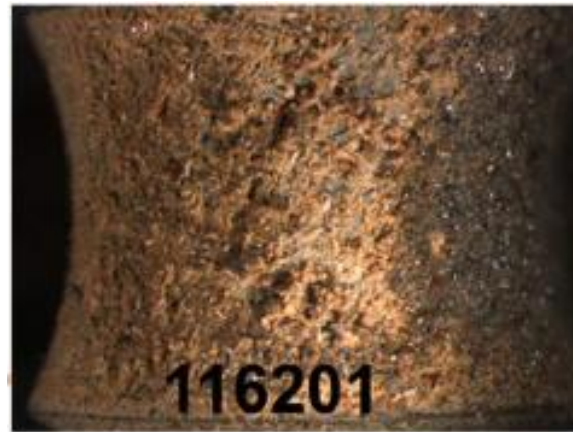
Optical examination – $\text{pH}_T = 4$ – liquid phase

No observable sign apart from oxidation

PbO

PbSO_4

600TT

690TT

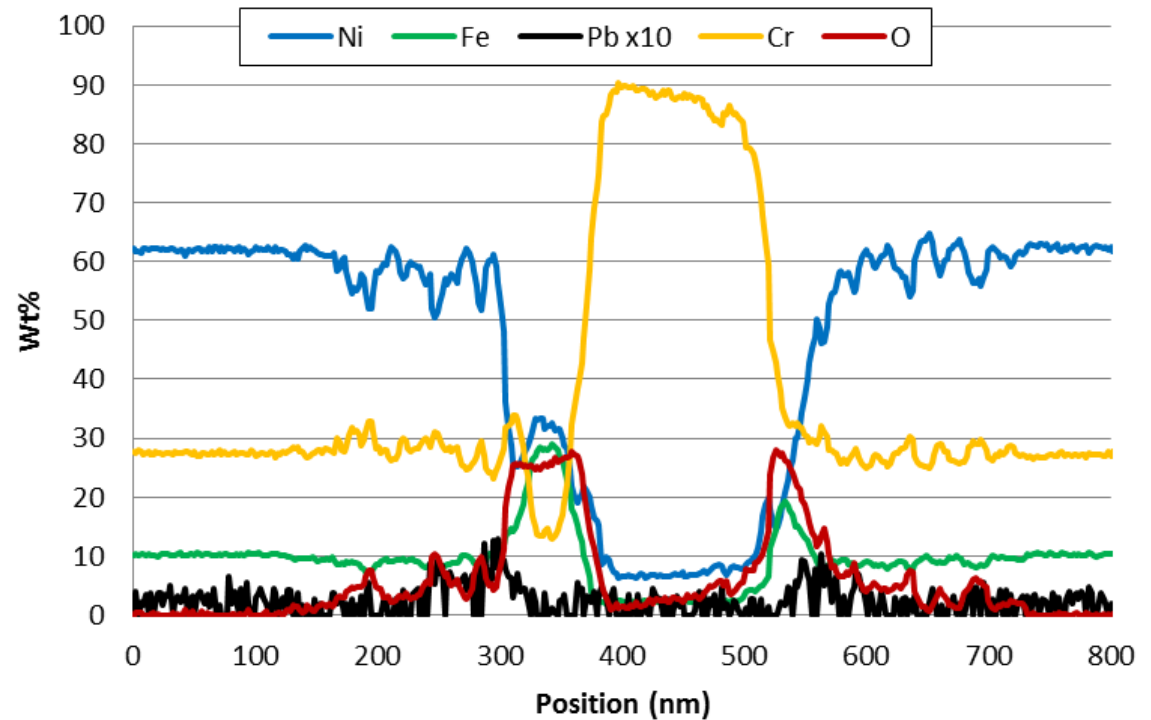
TEM – 690TT – PbSO₄ – pH_T 4 – liquid phase

- « Pure » Cr clusters
 - Surrounded by oxides
 - Alloy disturbances prior to oxidation
- Pb at the metal/oxide interface
 - ~1% wt of Pb
