Cristina Juanos Cabanas, Tchien Minh Tang, Pierre De Cannière

Bending Observed on the Carbon Steel Liner of the Pre-stressed Concrete Primary Containment of a Nuclear Reactor: Safety Assessment

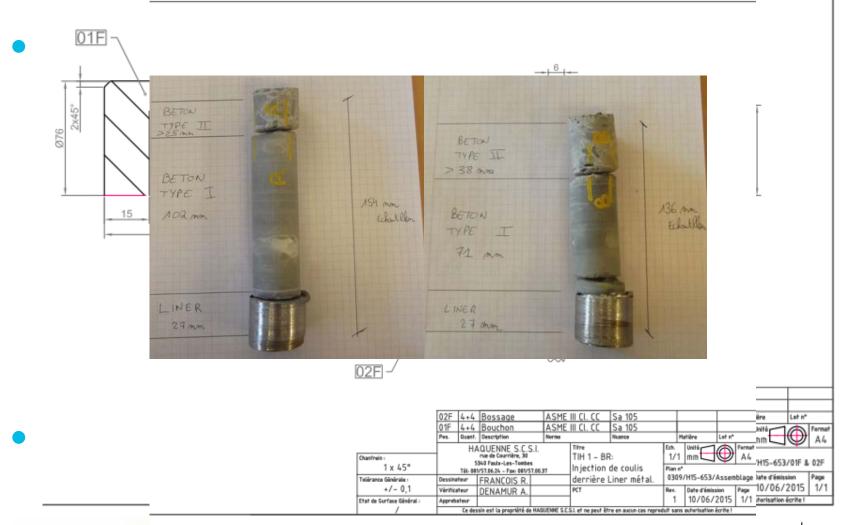
TECHNICAL ANALYSIS – STRUCTURAL SAFETY FUNCTION

- Bel V carried out a safety assessment:
 - Upholding of the structural safety function of primary containment in accidental conditions by demonstrating no damage on the primary containment:
 - Two drillings inside of the buckling through the carbon steel liner
 - Post-tensioning losses were checked
 - Bel V concluded that the structural safety function is ensured
